Inspection of Historic Building Facades for a Development of Restoration Project

Index Terms—Inspection, facades, pathology, restoration.

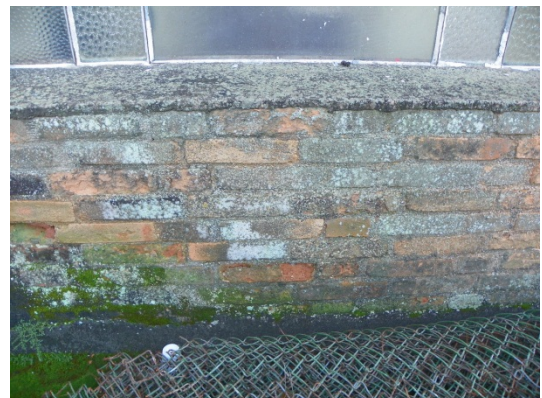
Fig. 2. Rising moisture in walls.

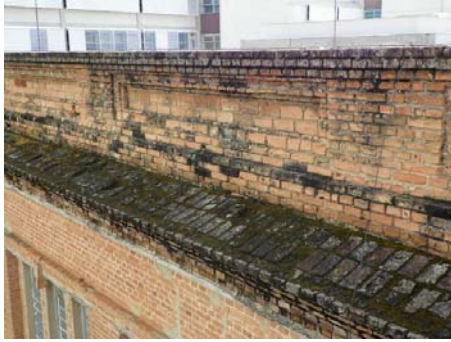
Fig. 3. Proliferation of biofilm.

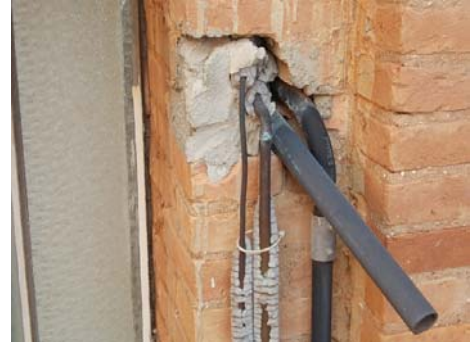
Fig. 8. Exposed pipes compromising the aesthetics of the facades.

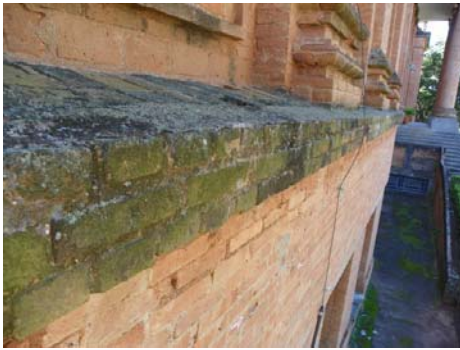
Fig. 4. Proliferation of biofilm.

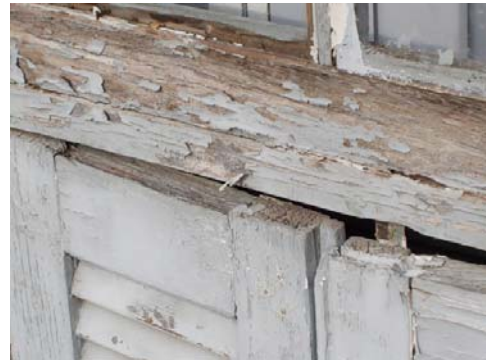
Fig. 9. Deterioration of wooden windows.

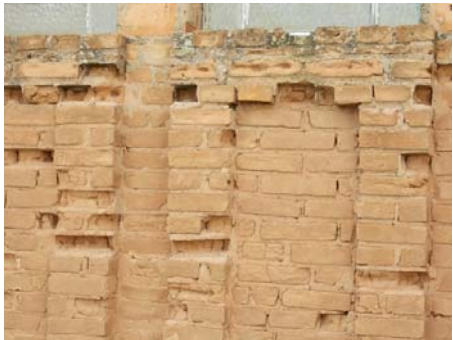
Fig. 5. Deterioration of bricks.

Although average compressive strength of the bricks have been appropriate, it should be borne in mind that, to be tested, the samples were of whole bricks, but there are regions in all fronts where the bricks are too deteriorated and must be replaced or filled with material that reproduces them in terms of aesthetics and strength.

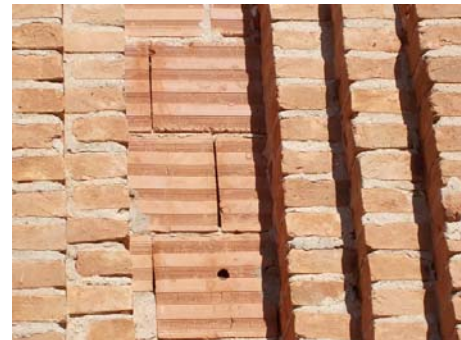
Fig. 10. Closing with bricks will differ from the original.

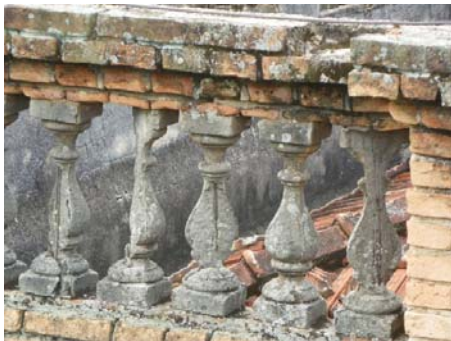
Fig. 6. Deterioration of concrete balusters.

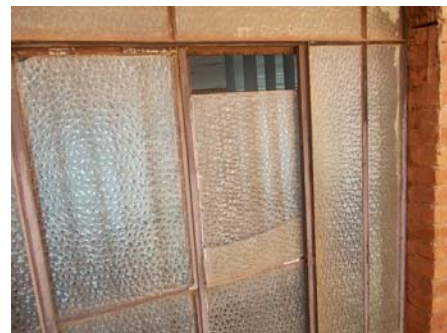
Fig. 11. Damage in metal windows.

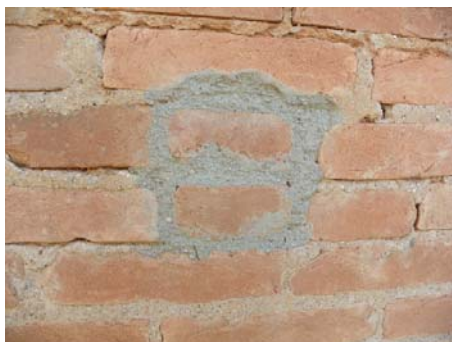
Fig. 7. Mortar different from the original.

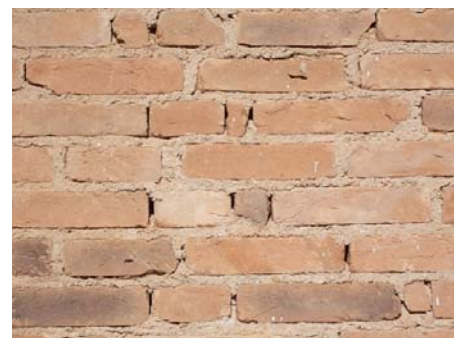
Fig. 12. Failures in laying mortar bricks.

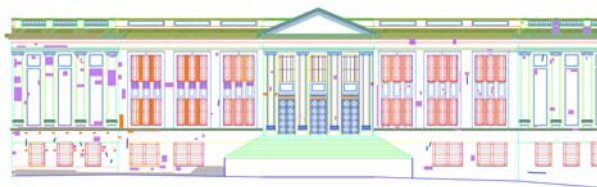
Fig. 13. Mapping of the pathologies on the facade.

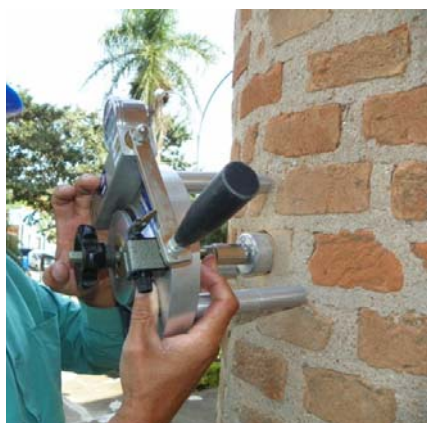
Fig. 14. Test of tensile strength – pull-off.

Only the specimens taken from the highest points in relation to the floor, did not meet the minimum strength of 0.30MPa, it is possibly due to the higher degradation observed in these areas. The other witness was sufficient to receive the repair procedures (Table I) resistance. Another point to be noted is the small thickness torn by the assay, ie, they did not break the bricks at greater depths, only superficially highlighted with small thicknesses (with caliper measurements).

The grip strength test tensile (pull-off) showed the possibility of applying repair or protection on the facades materials, provided that they are properly and thoroughly cleaned.

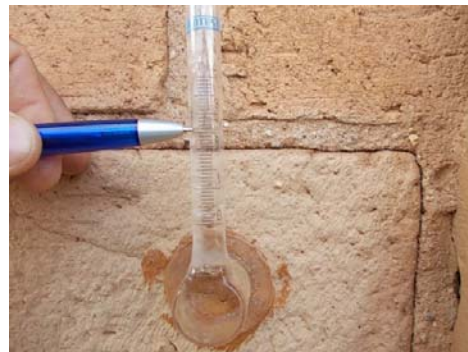
Fig. 15. Water absorption test.

The pipes numbers 7 and 8, which were fixed on whole bricks with low porosity, were the ones who showed absorption below the maximum acceptable value, and the pipes numbers 1, 2, 5, 6, 9, 10 and 11 which were fixed on porous bricks, showed high uptake.

The pipes paragraph 3, 4 and 12 were set on the bedding mortar and also showed high uptake (see Table II).

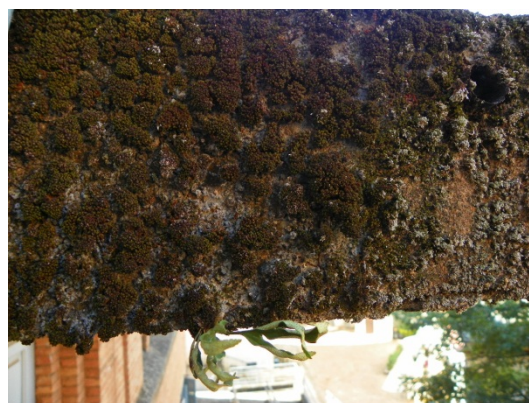
How have acidic pH, biofilms deteriorate most surfaces, by "etching" process, so for this work was convenient analysis of the pH of the biofilm, which is impregnated on the bricks in many areas of the building Fig. 16.

Fig. 16. Biofilm attached on brick.

Samples were collected at 16 points of facades and analyzed in the laboratory, which revealed the average pH value of 5.2 - confirming its acidity.

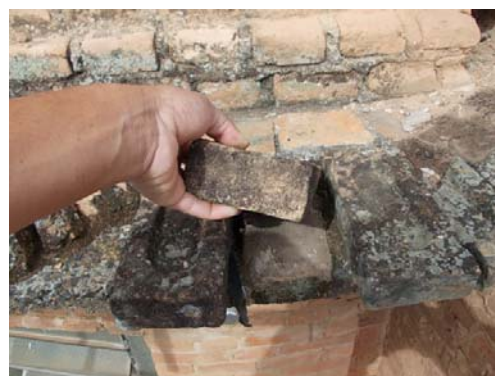
Fig. 17. Survey of brick with adhering biofilm - "A" sample.

The mean compressive strength was 8.3 MPa for Sample "A" and 9.3 MPa for Sample "B" can be considered as good resistance since the bricks are assayed sealing elements and non-structural bricks, however, we note that the group of bricks that had suffered attack biofilm resistance 10.75% lower than the unaffected by biofilm group.

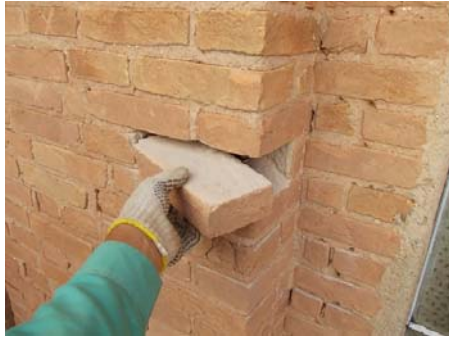
Fig. 18. Survey of brick without adhering biofilm - "B" sample.

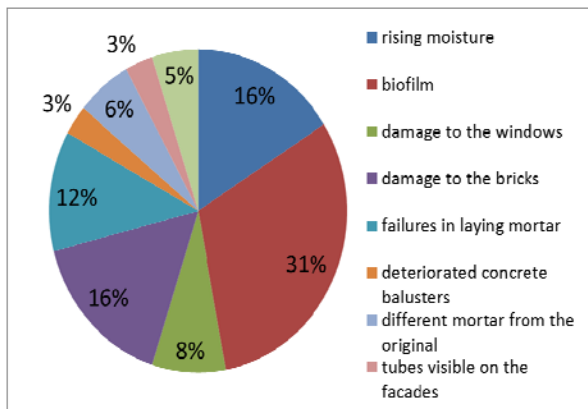
Fig. 20. Main pathologies.

Through inspection and tests carried out, it was possible to identify the proliferation of biofilm as pathology with greater incidence, which possibly occurs by the high porosity of the substrate and absorbing than recommended water, approximately 83 % of the tested points. The very architecture of the building with several recesses, their age and location - urban environment with high concentration of vehicular traffic - make it be susceptible to biofilm formation on their facades.
