Performance Evaluation of Cladding Stone in Buildings and Urban Works

Flain E., Righi R., and Frazão E.

Index Terms—Stone cladding, pathologies, stone veneers.

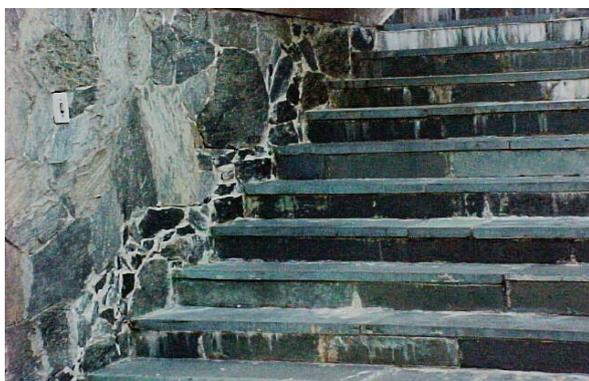
Fig. 1. Spots and efflorescence on the surface of the stone coating distributed slate. Residential building stairway, with approximately 5 years, in the city of São Paulo. Probable cause: excess water of kneading of the mortar.

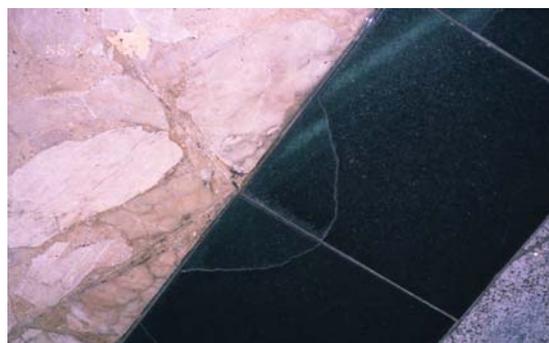
of rocky material. In addition to these may be associated with increased and by project failures Fig. 2.

Fig. 2. Crack in cladding stone. Probable cause: a deficiency in the distribution of the mortar of settlement.

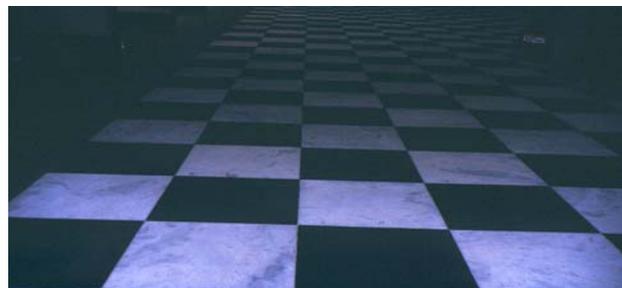
Fig. 3. Rocky plates use caused by excessive traffic associated with the different characteristics and properties of carbonate rock. Airport floors in the city of São Paulo.

The Fig. 3 features a floor coated with two types of rocks (a marble and a "granite") that have very different properties and characteristics, a lower wear resistance than the other. It is undeniable the aesthetic effect provided the floor as a whole but the use and tear caused on less resistant rock cause discomfort to passers-by when moving on the floor. This proves inadequate choice of Rocky materials since the same are being used side by side as a floor coating with high transit airport floor.

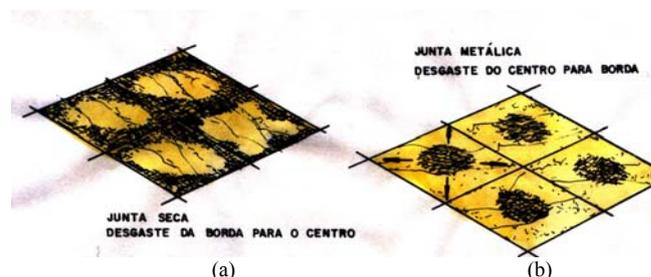
Fig. 4. The wear of rock plates associated to the characteristics and properties of the rock and the type of joint used. (a) Edge wear to the Center. (b) Wear from Center to edge.

The Fig. 4 presents two types of commonly used joints in coatings of floors and the effects caused by rocky material use when dry and metallic gaskets are adopted.

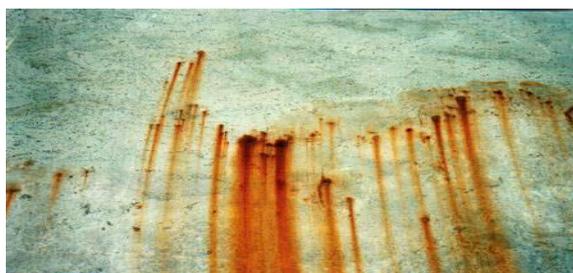
The rocks are made of minerals said essential, that serve to classify the type of rock; other minerals may be present, in the alternative, and are said to Accessories or varieties. Among these there are those that can decompose before environmental conditions, or microclimate, these unfavorable and, as a consequence, produce stains. Example of these components are the iron sulfides (pyrite, pyrrhotite and chalcopyrite) that can be present in common granites, metamorphic limestones and marbles; grenades in the dry white granites (albitites), nodules of clay black granites (diabases) and hypersthene in green granites (charnockites). There has been registered recently, several cases of staining orange or reddish colouration, granites and marbles, probably due to oxidation of pyrites of extremely small granulation (Fig. 5).

Fig. 5. Granite showing stains. Probable cause: oxidation of pyrites.

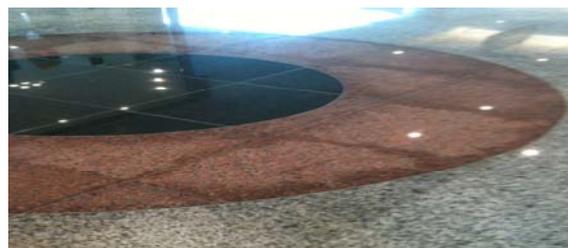
The water of kneading, when in excess, associated with excessive porosity of stone can cause stains on the surface of the coating immediately after the setting (Fig. 6).

Fig. 6. Occurrence of stains on granite. Possible causes: water-absorption of settlement and mortar or washing water surface.

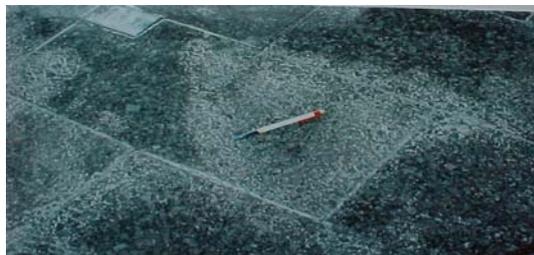
environmental, may change causing stains due to own products of its amendment or by providing the occurrence of efflorescence on the surface of the plates, regardless of those that may arise from the joints. Staining for mineralogical alteration or by efflorescence have, unfortunately, significant negative effect on the aesthetic finish shown in Fig. 7 a floor.

Fig. 7. Manifestation of mineralogical alteration of stone and occurrence of efflorescence. floor of the foyer building located at 3a. avenue, lined with granite coffee Bahia.

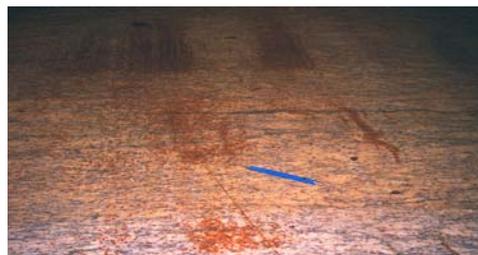
The production process-related pathologies were related in this text, however it is necessary to emphasize that all stages of the production process of these coatings are important to the end result expected. Fig. 8 illustrates the staining of a rock caused probably by the oxidation of grit used for sawing of boards. In one of the stages of the production process of these coatings an important aspect that should be remembered is that despite the Rocky materials present apparent feature of durability, they should not be stocked in the open and inappropriately as shown in Fig. 9 Characteristics of porosity and permeability and its geometry after the artificial shaping, provide superior requests when subjected breaks its resistance or staining when in contact with other materials, such as wood resin-coated, normally used for the execution of reinforced concrete molds or even by the chemical action of aggressive agents present in the atmosphere. Therefore, the transport and storage of the materials require specific care, aiming to prevent possible damage and decay, because its cost is significant in the total workforce.

Fig. 8. Rocky plate staining. probable cause: grit oxidation used in step of sawdust.

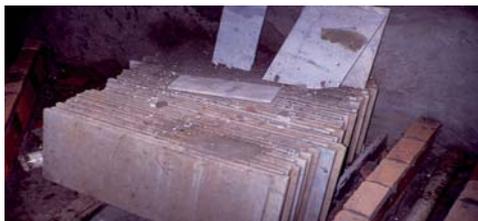
Fig. 9. Rocky material inadequate storage in construction site. may cause permanent staining before and or after placement.
