Evaluation and Remaining Life Assessment of Separator and Demister in a Geothermal Power Generation Plant

Meilinda Nurbanasari and Abdurrachim

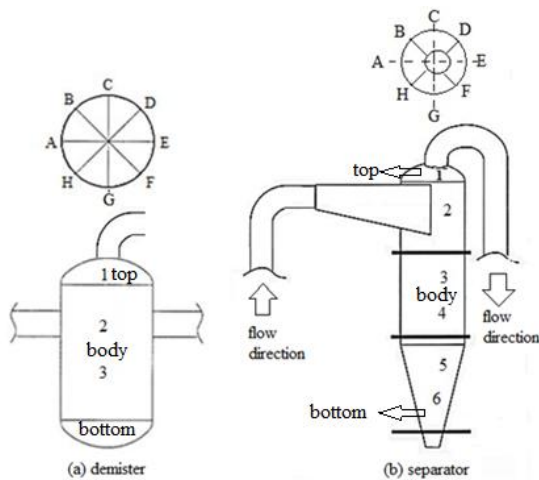
Fig. 1. Location for integrity inspection on (a) demister and (b) separator. For a description of numbers in the figure, see text.

In general, the inspected area was divided into three parts; top (number 1 on demister and separator), body (number 2 and 3 on demister, and number 2, 3, 4 on separator), and bottom (number 5 and 6 on separator). The area for internal defect inspection and thickness measurement is shown by number 1, 2, 3 on demister and 1, 2, 3, 4, 5, 6 on separator. The area for chemical composition determination was on the bottom of the equipment. The area for hardness test was number 1, 2, 3 on demister and number 2, 3, 6 on separator.

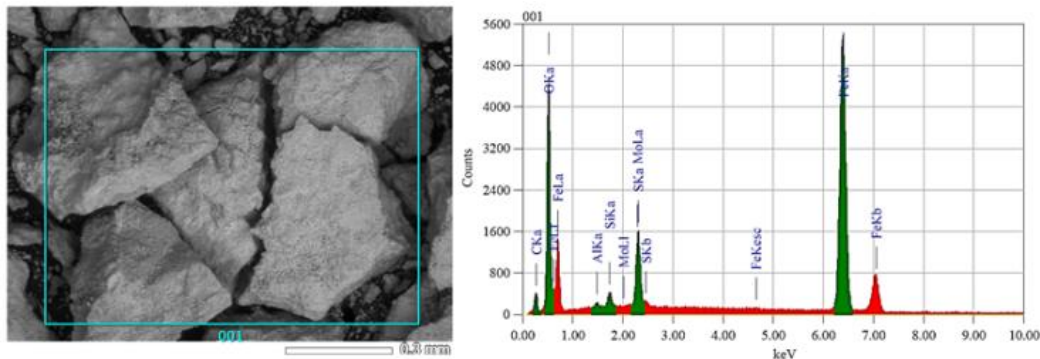
Fig. 2. SEM – EDS analysis of deposit from demister.

It can be seen that the deposit taken from demister contained of Sulphur, Aluminum and Silica. It is believed that both elements came from the geothermal as impurities and reacted with oxygen in the demister producing scale [9]. X ray diffraction was used to identify the compound in the deposit and the result is presented in Fig. 3.

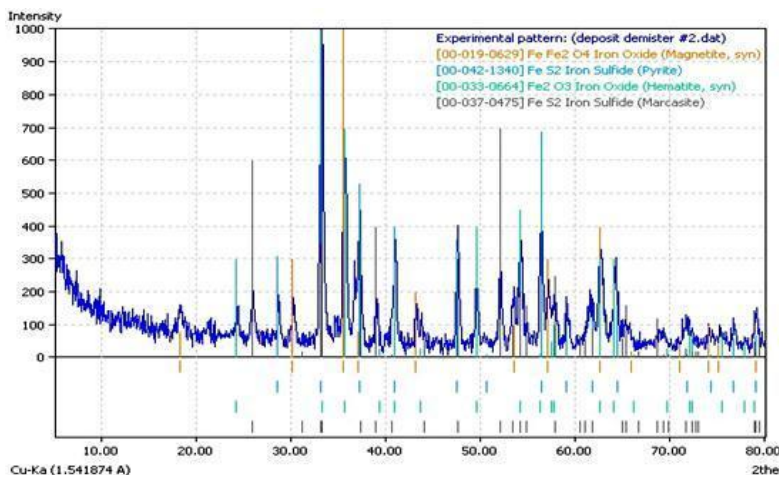
Fig. 3. X-ray diffractograms of deposit.

X rays diffraction detected some peaks in good agreement with Fe₃O₄, FeS₂, Fe₂O₃ and FeS₂. The presence of iron oxide on deposit gives strong evidence that corrosion had occurred inside the demister. No indication in the Fig. 3, the peak belongs to Silica compound. It seems that the scale containing Silica in the deposit is less than 5 % that cannot be detected by XRD. The corrosion and formation of scale occurred simultaneously that cause reduction in thickness wall of the equipment.
