# The City Hall of Mirandola Hardly Hit by the Earthquake of 2012: Damage Assessment and Approaches for the Seismic Improvement

M. Bonariol, G. Boscato, A. Dal Cin, D. Fiorotto, and S. Russo

Abstract-The City Hall of Mirandola was stricken and damaged by Emilia-Romagna earthquake sequence of May 2012. The research suggests solutions for the rehabilitation of a masonry historic building that presents a serious damage pattern. The solutions includes the base isolation of the global structure. Through the historical analysis, the damage survey and the mechanisms analysis were defined the macro-structure of the palace. Subsequently, was generated different configurations based on the aggregation or separation of the five macro-structure identified. The separation of these proposed projects is done through the use of seismic isolators and dampers. It was carried out a simplified finite element model and the linear elastic dynamic modal analysis was performed to evaluate the main modes of vibration of each configuration, which correspond to the higher values of percentage of participating mass. Finally a response spectrum analysis was performed with the use of data of the earthquake of

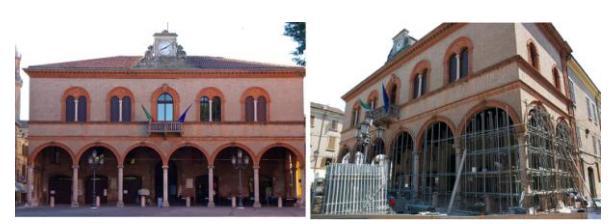
Fig. 2. View of the City Hall pre and post earthquake.

The earthquake has severely affected the structure. The loggia has been a northward shift that resulted in the posting of this part from the main volume. The back wall has many vertical cracks that indicate a crushing of the masonry due to the stress of the overlying loads (a heavy steel cover's structure of a recent restoration) that have gone to weigh in this longitudinal wall. The columns of the loggia have well reacted to the seismic action. The side arches of the loggia present cracks in the cornices due to the displacement along their main axis (x) (Fig. 1) which led the formation of hinges.

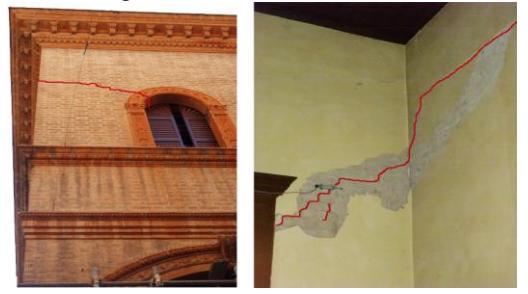
The main room 'Sala Granda' has suffered several cracks, particularly along the shorter side walls. Observing Figure 3 the trend of the crack is visible inclined, it propagates from

the opening of the shorter side wall up to the facade. The displacement of the greater mass of the entire building to the north has caused an overturning mechanism of the facade.

Fig. 3. View of the inclined crack of the overturning mechanism of the facade.

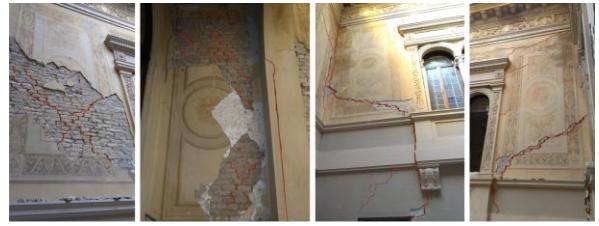
The volume of the important staircase presents a very serious crack pattern (Fig. 4), the lesions were detected particularly along the longer sides on the east and west probably because the higher NS seismic component caused larger displacements of the entire building along the x axis (Fig. 1). The collapse of the plaster in some areas of the perimeter walls allows us to analyze the texture of the walls and conseguently of the crack below. The presence of multiple lesions 45 °inclined, often by sliding joints suggest a collapse of shear type. Some lesions very deep propagate throughout the height of the volume.

Fig. 4. View of the damaged pattern of the perimeter wall of the staircase.

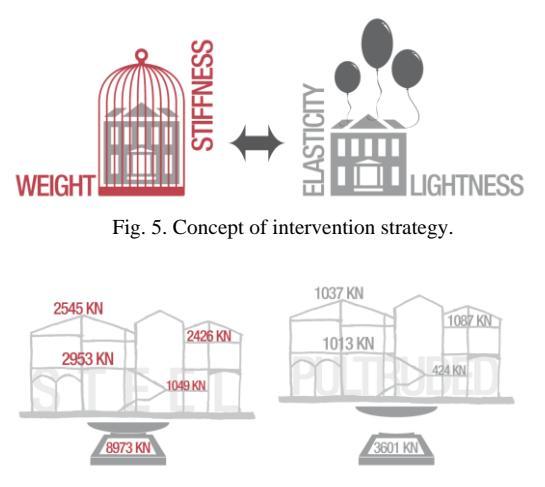
Fig. 6. Comparison of the weights of the floors.

As for the light, the proposal is to replace the steel beams of the roof and the floors structures with pultruded beams, fiber-reinforced composite material that weighs 80% less than steel with the same strength. Have been calculated the loads of a floor with steel beams and brick of the city hall, equal to 2.96 KN/m<sup>2</sup>. This result was compared with those of

a floor in pultruded beams, equal to  $1.4 \text{ KN/m}^2$ , demonstrating a decrease of more than 50% in exchange of only a slight variation in the package thickness of 5 cm (Fig. 6).

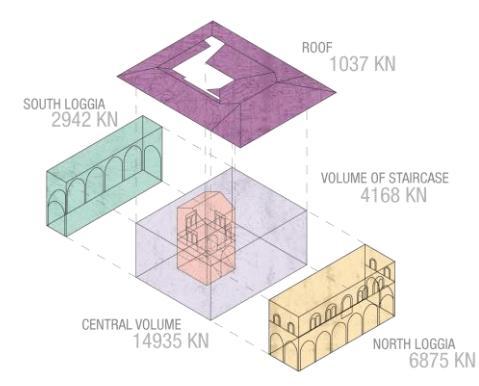
Fig. 7. The different masses that compose the building.

It is important to remember that the town hall was the result of the aggregation of several structures, hence the idea to ensure that these masses have the ability to move separately rather than working as a rigid box.

It is therefore proposed to separate and reconnect through the damper the different masses (Fig. 7), so try to dampen the vibrations and ensure that the bodies move separately without damage, or at least lessening the severity of the cracks.

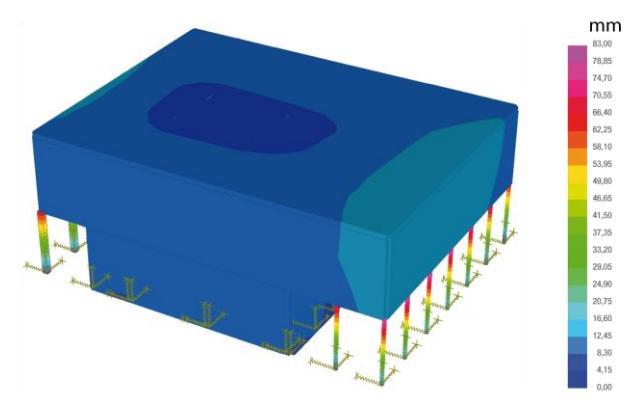
The results show that the critical part of the structure with the larger displacements appears to be the north face at the level of the "Sala Granda", supported only by marble columns. This is not found in the configuration with three masses with separation staircase and loggia, which, however, presents a high stress concentration on the part of the wall in contact with the roof (Fig. 12).

Fig. 12. FEM model of the structure subjected to earthquake ground motion with base isolation.

Finally, it possible to confirm that the best solution appears to be the base isolation; alternatively leads to advantages although the configuration consisting of three masses staircase, hall and also with the separation of the loggia.
