# Glass Fiber versus Carbon Fiber Grid used in Textile Reinforced Mortar Strengthening of Precast RC Walls

C. Toduț, V. Stoian, and I. Demeter

**Abstract**—The experimental study presented here is based on the seismic performance investigation of precast reinforced concrete wall panels (PRCWP), post-damage strengthening using different materials and different anchorage systems. Both wall panels have an initial small window opening, but the second panel has the opening enlarged into a large window opening in order to investigate also the cut-out effect. The behavior and failure details are presented and analyzed for both unstrengthened and post-damage strengthened situations. The economic aspect will also be discussed for each of the strengthening systems used.

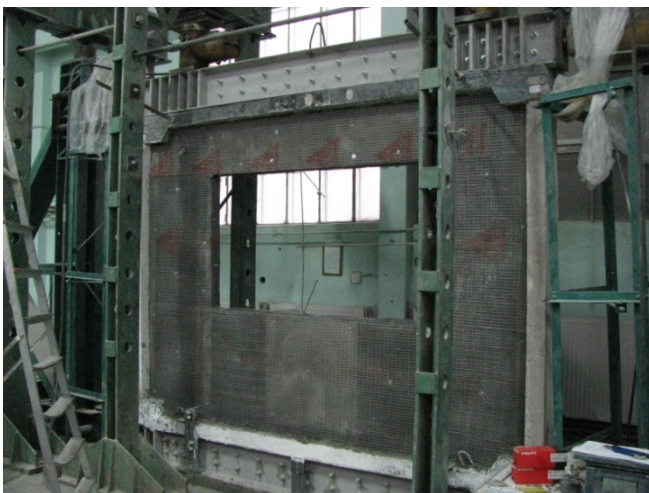
Fig. 2. Glass fiber grid and punctual anchorage application

In the case of the post-damage strengthened wall having a small window opening enlarged to a large window opening, the strategy applied was based on TRM using GF grid and a punctual type of anchorage using threaded rods. After repairs, the surface of the wall was polished, 8 mm holes were drilled for the threaded rods, the corners of the opening were rounded 20 mm and the wall surface was vacuum-cleaned. First, the threaded rods (6 cm length) were fixed using resin through the panel. According to the retrofitting plan (Fig. 1), the SikaWrap 350 G grid was cut using scissors considering their dimensions. The bonding primer (SikaMonotop 910 N) was then applied on the surface of the wall, followed by the first layer of mortar, the GF grid (Fig. 2) and last the second layer of mortar (Fig. 3) “to be published” [7]. The mortar from the TRM system was a 1-component mortar, mixed with water (SikaMono Top 722 Mur). The material consumption here comprised 18 m<sup>2</sup> of glass fiber grid, 98 threaded rods, 1 kg of resin for the anchorage, 35 kg bonding primer and 175 kg component mortar in TRM. Strain gauges were mounted on steel reinforcement for the unstrengthened wall and on the GF grid for the strengthened wall.

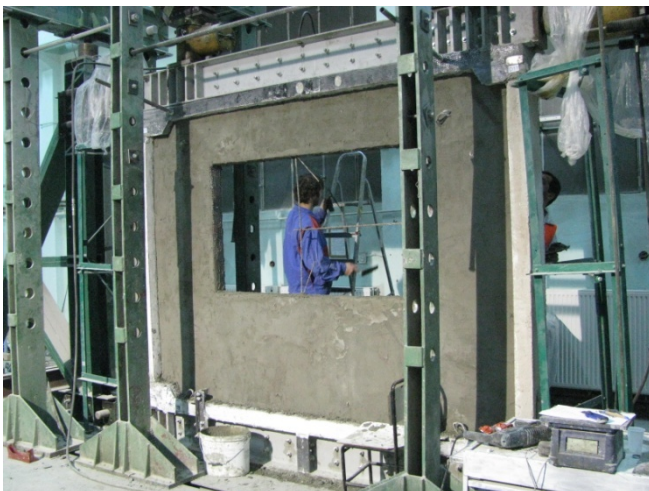
Fig. 3. Second layer of mortar application

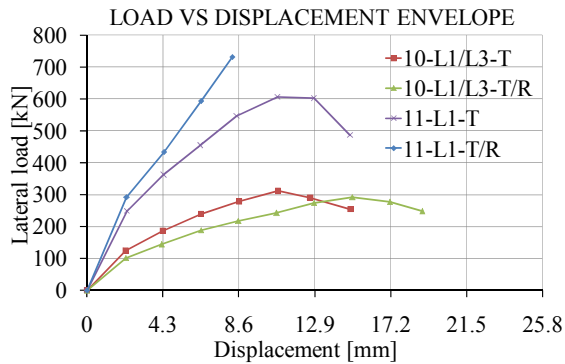
Fig. 8. Load-displacement envelope curves

Fig. 8 represents the load-displacement envelopes for the four experimental tests performed on the precast RC wall panels, while Fig. 9 shows the stiffness degradation curves. Fig. 10 and Fig. 11 show the strain-displacement diagrams.

In terms of maximum load supported by the element the unstrengthened PRCWP (10-L1/L3-T) recorded 344 kN while the post-damage strengthened one (10-L1/L3-T/R) 320 kN. Drift level corresponding to the maximum load was 12.93 mm for the unstrengthened wall while for the post-damage strengthened one was 14.98 mm. The maximum load supported by the unstrengthened PRCWP (11-L1-T) was 793.5 kN, while for the post-damage strengthened one 1007.5 kN. Drift level corresponding to the maximum load was 12.59 mm for the unstrengthened wall while for the post-damage strengthened one was 8.02 mm. Investigating the cut-out effect made in the wall panel due to the window enlargement we obtain a decrease in load bearing capacity of 56%. In the case of PRCWP (10-L1/L3) the initial load bearing capacity of the element was almost restored. The PRCWP (11-L1) could not be taken to failure due to the available capacity of the testing facility, but analyzing the data one can remark that at a displacement level of 8.02 mm we have an increase in load bearing capacity of 60%. Strain gauge G2 located on glass fiber grid (right pier, midpoint) ranged only up to approximately 2.4 ‰ in tension. Strain gauge G6 applied on carbon fiber grid (at the left upper corner of the opening on an inclined strip, number 6) ranged from approximately -2.2 ‰ in compression until +11.5 ‰ in tension. Concerning the economical aspect, we obtained a cost per square meter of 90.25 EUR/m<sup>2</sup> for PRCWP (10-L1/L3-T/R) using glass fiber grid and 276.42 EUR/m<sup>2</sup> for PRCWP (11-L1-T/R) using carbon fiber grid. The prices given in tables are valid for Romania, for the current period. The strengthening using TRM with carbon fiber grid proved to be the most expensive, but we have to take into consideration the fact that the crack injection was not performed in the other case, the steel fiber cord is a high performance anchorage type and its price is in accordance with it, and also the idea of strengthening versus retrofitting implying the carbon fiber grid wraps raised the total price. Both systems proved to be efficient, except the punctual type of anchorage which reduced the costs but led to debonding.

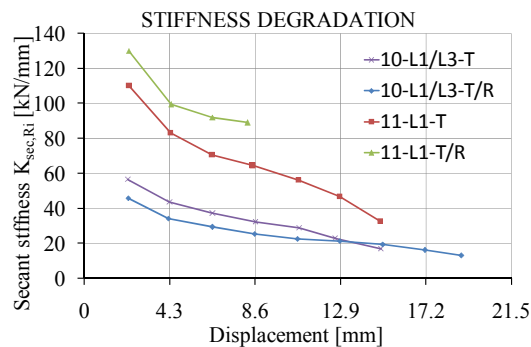
Fig. 9. Stiffness degradation curves

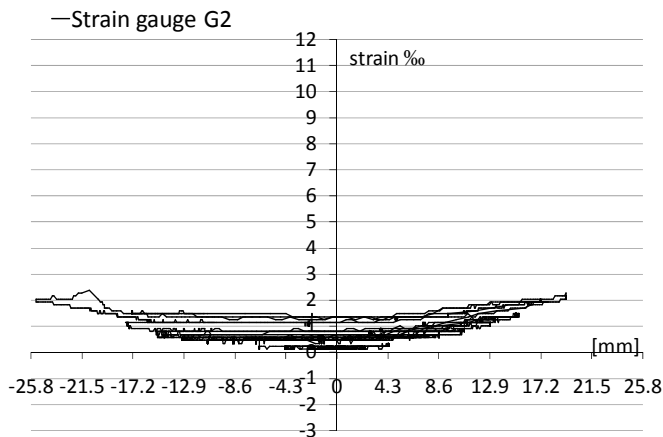
Fig. 10. Strain-displacement diagram for G2 (10-TR)

Fig. 10 represents the strain-displacement diagram for G2 strain gauge (PRCWP 10-L1/L3-T/R) on glass fiber grid, and Fig. 11 for G6 (PRCWP 11-L1-T/R) on carbon fiber grid. Table I and Table II show the TRM strengthening costs for PRCWP (10-L1/L3-T/R) using glass fiber grid and PRCWP (11-L1-T/R) using carbon fiber grid. All the results will be discussed in the conclusion section.

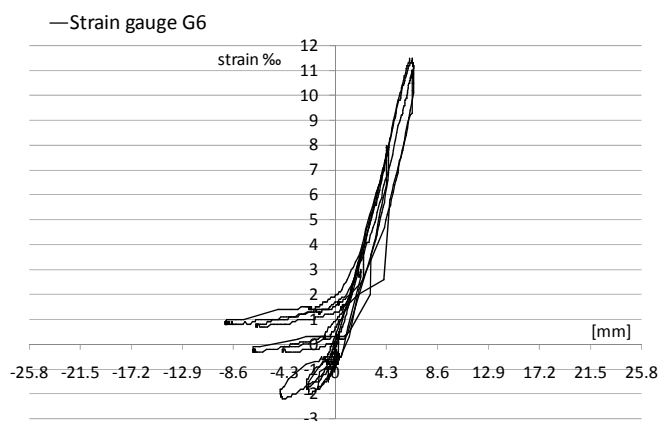
Fig. 11. Strain-displacement for G6 (11-TR)
