Differential Settlement at Bridge Approaches' in Bangladesh

Md. Firoz Mahmood Ovi, Md. Ridwan Bin Alam, Abontee Barua, S. Halder, and Md. Waliur Rahman

Index Terms—Bangladesh, bridge approach slab, differential settlement, mitigation techniques.

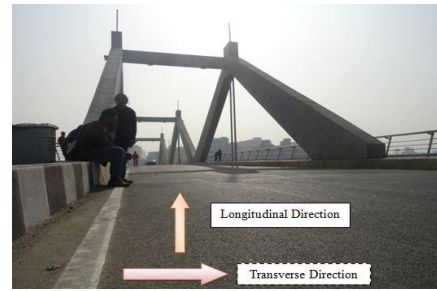
Fig. 4. Hatirjheel 4th bridge, dhaka, Bangladesh.

Visual inspection carried out at Hatirjheel 4th Bridge, Dhaka, Bangladesh (shown in Fig. 4) indicated differential settlements was 1.328 inches at the interface between the approach fills and bridge in longitudinal direction (data used are given in Table II) and 1.52 inches in transverse direction (data used are given in Table III). The Distance vs. Settlement Graph longitudinal is shown in Fig. 5 and The Distance vs. Settlement Graph transverse is shown in Fig. 6. The survey indicated differential settlement of about 0.6 to 1.7 inches near abutments (within 8 feet) in longitudinal direction. The transition slope (differential settlement divided by approach length) was calculated to be about 0.157 to 0.453 inches per foot for the North abutment of Hatirjheel Bridge, Dhaka, Bangladesh.

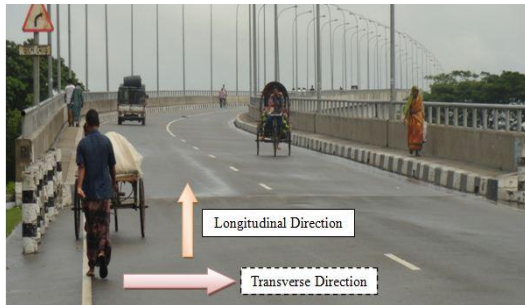
Fig. 7. Shaheed abdur rab serniabat bridge, barishal, bangladesh- east abutment.

Visual inspection carried out at Shaheed Abdur Rab Serniabat Bridge, East Abutment, Barishal, Bangladesh (shown in Fig. 7) indicated differential settlements was 1.304 inches in longitudinal direction (data used are given in Table IV) and 1.110 inches in transverse direction (data used are given in Table V). The Distance vs. Settlement Graph longitudinal is shown in Fig. 8 and The Distance vs. Settlement Graph transverse is shown in Fig. 9. The survey indicated differential settlement of about 0.394 to 1.575 inches near abutments (within 8 feet) in longitudinal direction. The transition slope (differential settlement divided by approach length) was calculated to be about 0.074 to 0.394 inches per foot for the east abutment of Shaheed Abdur Rab Serniabat Bridge, East Abutment, Barishal, Bangladesh.
