7KH ,QYHVWLJDWLRQ DQG 'LVFXV 6LWXDWLRQ RI ROG 5HVLGHQF

Abstract² There are a huge amount of old residential buildings in Shanghai which involve a large number of residents. With the aging of the buildings, structural or architectural problems are exposed. Therefore, it is necessary to investigate the old residential buildings. This paper collects the data of 34 old residential clusters in three districts of Pudong New Area of Shanghai by means of questionnaire and field survey. It analyzes the causes of the differences in architectural problems of old houses in different regions, different ages and different types of structures. This paper also probes into the causes of structural problems of old residential buildings. And it accumulates important basic data for improving the comprehensive renovation level of old residential buildings and perfecting related laws and regulations in Shanghai.

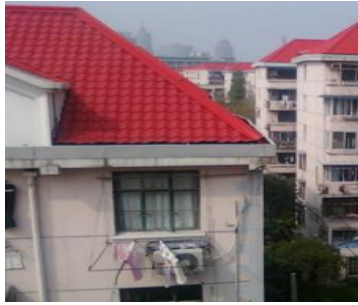
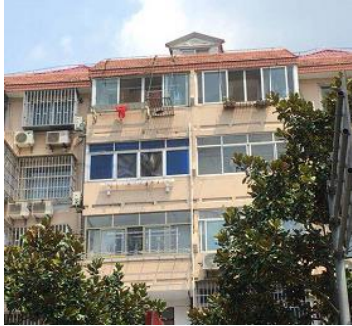
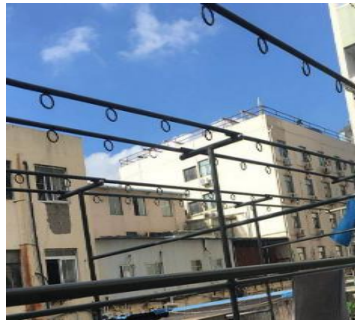
)LJ & RORUSO/DWHHO

Comparing with Fig. 2, Fig. 3 and Fig. 4, it is not difficult to find that the popularity of color steel and resin tiles on sloping roofs in city center A and more developed townships B is very high, but in remote townships C, the usage of color steel is very low, and most of them are still at the level of pottery tiles and clay tiles. The color steel plate has the advantages of light weight, good thermal insulation effect, high flexural strength and high compressive strength. It is convenient to install and time saving. Resin tile has good compressive and impact resistance, also has good refractory and corrosion resistance, it is adiabatic, soundproofed, energy-efficient and difficult to fade. However, terracotta and clay tile tend to crack and become deformed because of agglomeration. Cracks lead to seepage while expanding. The area of each piece is small. Therefore, it needs more pieces to cover the same roof, which leads to its heavy weight. It tends to be mossy and fall off. Consequently, resin tiles and color steel plate have great

advantages over traditional tiles Fig. 5, Fig. 6 and Fig. 7 are some pictures taken on the spot.

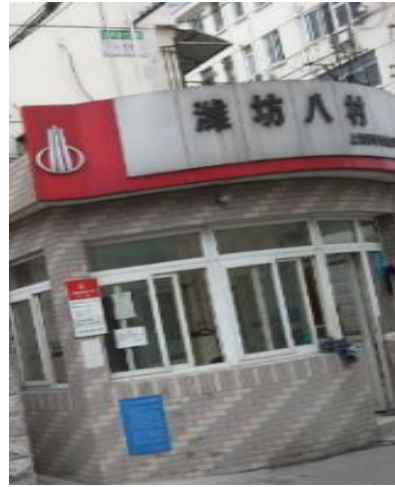
Fig. 9. Duty room

is high and the difference is not obvious. However, there is a discrepancy in ancillary facilities between cities and towns. Developing towns have more room to upgrade in this respect Fig. 9-12 are some pictures taken on the spot

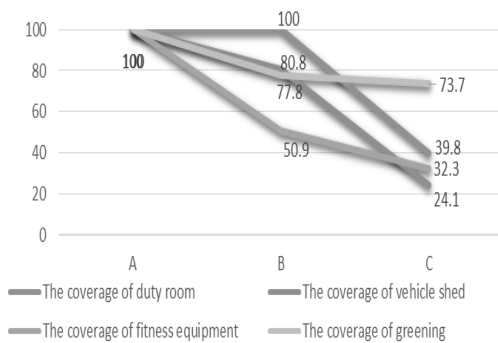
)LJ 7KFRYHU DJH RI DLQWURJUDLGH QDQD

From the Fig. 8, it can be seen that the coverage rate of duty room, vehicle shed, fitness equipment and greening in the urban center is better than that in the township, that is, the ancillary facilities and greening level of the community are positively correlated with the economic development level of the area. Among them, the overall level of greening

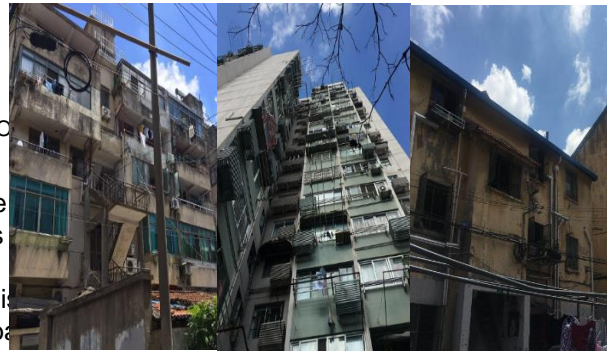
Fig. 20. Brick-concrete Fig. 21. Frameshearwall. Fig. 22. Small beam and thin slab

reduced a lot. The disadvantages of traditional steel structure, the traditional brick-concrete structure, the frame-shearwall structure and relatively rare brick-concrete structure with small beam and thin slab. The comparison among the three structures are in Table II. Fig. 20-24 are some pictures taken on the spot. However, aluminum alloy windows have many advantages such as light weight, high strength, good sealing, small deformation, good corrosion resistance and elegant facade, which make them much better than steel windows. Fig. 14 and Fig. 15 are pictures taken on the spot.

Structure	Advantage	Disadvantage
traditional brick-concrete structure	It has good durability. The construction process is simple and is easy to operate. Its sound insulation performance is good and the cost is low.	The overall stiffness seismic performance and horizontal load resistance are poor. It is not suitable to be high-rise building or provide large space.
frame-shearwall structure	It has good seismic performance and flexible layout of building space. The lateral stiffness is high. The size of beam and column is small and convenient for construction.	The structural ductility is poor and cannot provide large space.
brick-concrete structure with small beam and thin slab [1]	The cross section of the beam is small, the floor cover is thin and the weight is light. The construction is convenient and quick. The cost is low.	The durability is poor. The precast beam plate is easy to swell and damage, appearing the phenomenon of rusting or protection layer cracking. The end of prefabricated small beam might be loose.
