# Trial Panels – A Useful Prerequisite for Cut off Wall Execution: Upper Gotvand Dam

**Abstract**—Right abutment of Gotvand Dam, the highest rock fill dam of Iran is featured by dislocated materials and anticline. Thus initial sketch of grouting curtain has been replaced by cut off wall to make it sufficiently water tight. Trial panels can illuminate probable practical obstacles for major phases. The purpose of study was to evaluate execution of support reinforced walls, brushing operation, slurry quality, and excavation efficiencies. Assessment of joint and contacts regarding accomplishment method for basement concrete has been another objective. Thus two trial phases were practiced. Then using survey panels, core sampling, and qualitative monitoring of slurry, several beneficial data were elicited. Longitudinal brushing couldn't be performed effectively. Lack of excavating completion surface provides tighter joints in between basement concrete and cut off panels. In order to prevent clay entrance in between panels and support lateral wall, guide wall has to be fabricated in same width as cutter length, otherwise differential has to be implemented as tolerance into inner panels.

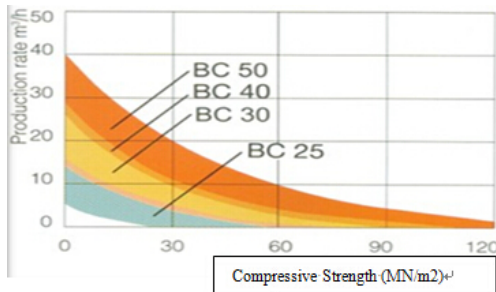
transferred normal force to bed rock through bits, and then affect excavation efficiencies (see Fig. 1) Bits' type influences operation as well (see Fig. 2) [1].

Fig. 1. Production rate, cutter size effect.

- 1) Regarding trench cutter size effect on excavation power, BC30, 40, and 50 were assigned for various cut off phases respectively, in which more stiff layers like conglomerate, sand stone, and mud stone were exist. Proportionate support facilities such as enough cutter bits have to be provided as well.

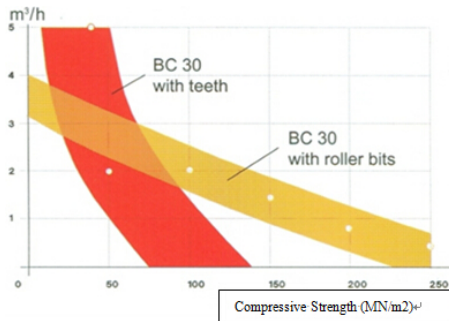
It is notable that ordinary bits (Sb) is used to cut formations with uniaxial compressive strength up to 50 MPa, whereas rock bits (RSC) and Roller bits are applied to excavate stones with compressive strength of about (50-100) and upper 100 MPa respectively.

Fig. 2. Production rate, cutter bit effect.

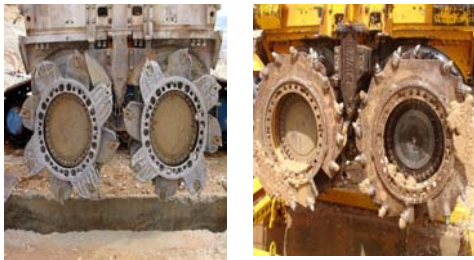
We've taken advantage of mentioned blades during trial panel cutting operation in Fig. 3.

Fig. 3. Cutter wheel, Sb blades (a), RSC bits (b).

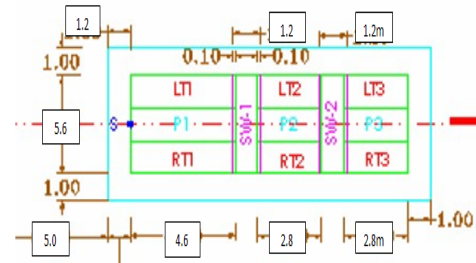
Devised panels were grouped as P panels, lateral right panels RT, lateral left panels LT, and survey panels SW in Fig. 4.

Fig. 4. Experimental panels' sketch plan.

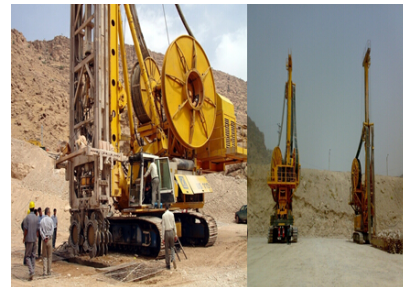
Layers similar to right abutment disturbed zone. An excavating machine named BC30 produced by BAUER Corporation was chosen to accomplish experimental panels PT1, PT2 with 80 meters depth.

In lateral and survey panel operations, 177.7 m depth in an area of about 392.1m<sup>2</sup> was dug out by BC 40 in Fig. 5.

Fig. 5. BC 30 sets on PT2 platform (a), used BC30, BC40 (b).

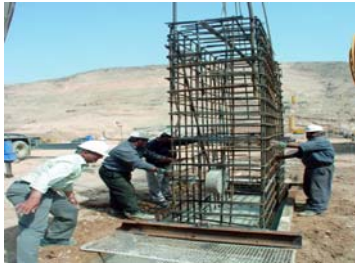
As we mentioned before, weak geotechnical situation of right abutment will cause remarkable forces on plastic concrete cut off wall because of recent and prospective settlement and movements. In order to be protected, two lateral reinforced walls were proposed all along cut off wall in both sides. Thus three panels, RT1, RT3, and LT1 were chosen to examine operation and foresee probable obstacles for major phases in Fig. 6.

Bar cage has 20 cm concrete cover in width as the interface with couple adjacent panels and 10 cm in length.

Fig. 6. Bar cage placement, guide frame.

A guide frame with two guide plates, installed on each side was applied to direct bar cage into panel. To direct cage more accurately and to fix it specifically during concrete placement 4 roller shaped concrete pieces have been applied.

Of course concrete covers were contemplated as well. Cage was hanged in 0.3 to 0.6 m of panel bottom and 1.3 m of guide wall surface at top for RT1 and PT1 panels. To simulate lateral walls in actual cut off wall axis more accurately, top space of about 3m was considered for RT3.

- 5) Reinforcement cage has to be designed and assembled with arranged pins so that tremie pipe can easily pass through and ball could return from bottom to the surface as well.

- 6) Cage has to be fixed in an appropriate space of bottom. Seating on panel bottom makes cage polluted with dirty mud. In contrast cage might move during concrete placement, if too space was available in between.

- 7) Guide frame has to be tightly connected to panel surface guide wall. Guide plates have to be extended deep enough to direct cage more accurately as well.

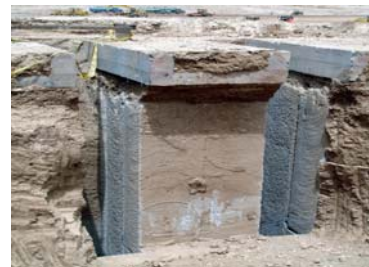
SW1 was excavated to 7.3 m deep in 3.6 m length and continued by 2.8 m length to 12.5 m deep. This section change was occurred because of two reasons. Collision to lower part of RT1's cage. Besides high vibration made of cutting operation in 30 MPa basement concrete specifically when cutter isn't confined in 2.8 m precut side and cutter wheel flaps couldn't be applied efficiently. When SW2 get started, installed cage in RT3 moved upward and diverted into SW2 cutting path. Thus operation was continued in between LT2, P2, LT3, and P3 in standard cutter length 2.8 m with no corrupting cages, deep to 10.2 m. Finally to make precise observation possible an access trench was cut, deep to basement concrete surface (see Fig. 7).

Fig. 7. Observation trench.
