# The City Hall of Mirandola Hardly Hit by the Earthquake of 2012: Damage Assessment and Approaches for the Seismic Improvement

M. Bonariol, G. Boscato, A. Dal Cin, D. Fiorotto, and S. Russo

Abstract-The City Hall of Mirandola was stricken and damaged by Emilia-Romagna earthquake sequence of May 2012. The research suggests solutions for the rehabilitation of a masonry historic building that presents a serious damage pattern. The solutions includes the base isolation of the global structure. Through the historical analysis, the damage survey and the mechanisms analysis were defined the macro-structure of the palace. Subsequently, was generated different configurations based on the aggregation or separation of the five macro-structure identified. The separation of these proposed projects is done through the use of seismic isolators and dampers. It was carried out a simplified finite element model and the linear elastic dynamic modal analysis was performed to evaluate the main modes of vibration of each configuration, which correspond to the higher values of percentage of participating mass. Finally a response spectrum analysis was performed with the use of data of the earthquake of

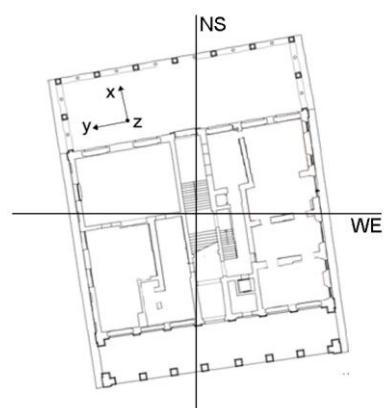
Fig. 1. Plans of the palace with the indication of the N-S and E-W directions.

The damage surveys of the palace confirm that the larger displacements of the entire building have occurred along the x axis (Fig. 1).

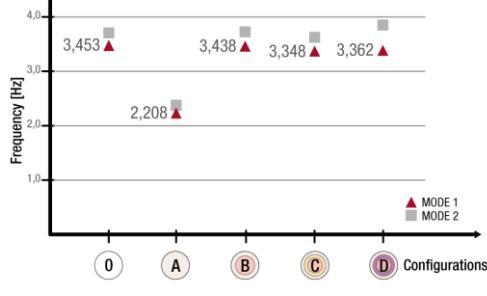
Fig. 10. Graphic analysis of the frequencies.

The outcome of the analysis of the frequencies of the structure in its different configurations, it is possible to observe constancy in the values for the three alternatives (Fig. 10). The initial configuration presents the first frequency of 3.453 Hz, a value that can be considered acceptable compared with that resulting from the identification test conducted on the data collected by the structural monitoring, completed in the months after the earthquake, which is equal to 2.73 Hz. Finally, it is possible to confirm that the first configuration, as expected, is characterized by a strong reduction of frequencies, due to the isolation at the base.

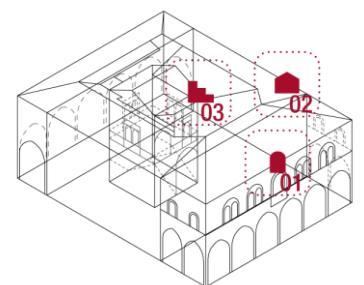
As regards the main displacements, corresponding to the three bodies analyzed, occur in the Y direction, mostly concentrated in the upper part of the city hall in the North facade and in the floors in contact with the structure of the staircase (Fig. 11).

Fig. 11. Reading points for movements and stresses.

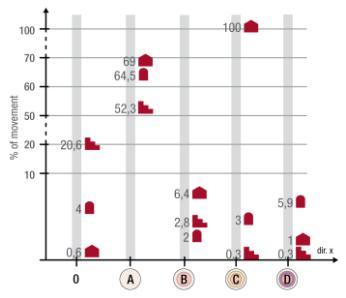
Fig. 13. Displacements analysis in X-direction.

From the graphs of the displacements (Fig. 13, Fig. 14) can be seen that:
