Inspection of Historic Building Facades for a Development of Restoration Project

Index Terms—Inspection, facades, pathology, restoration.

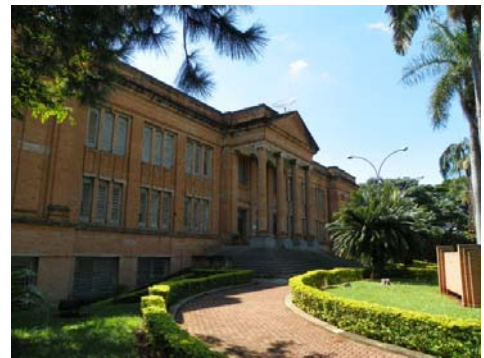
Fig. 1. Partial view of the building.

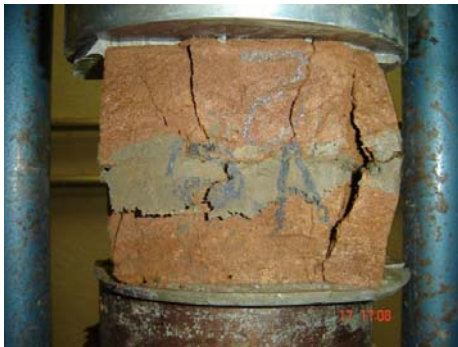
The preparation of specimens and testing of compressive strength were carried out at the Laboratory of Building Materials, Faculty of Technology, UNICAMP (see Fig. 19),

Fig. 19. Evaluation of compressive strength of bricks.
